REPORT on the GEOLOGIC and GEOMORPHIC CHARACTERISTICS of the MATTOLE RIVER WATERSHED, CALIFORNIA

Clifton W. Davenport, CEG, CHG;
Jennifer Thornburg CEG, CHG; Marc P. Delattre CEG;
Wayne D. Haydon CEG; and John M. Curless CEG

Prepared in cooperation with the
CALIFORNIA RESOURCES AGENCY'S
NORTH COAST WATERSHED ASSESSMENT PROGRAM

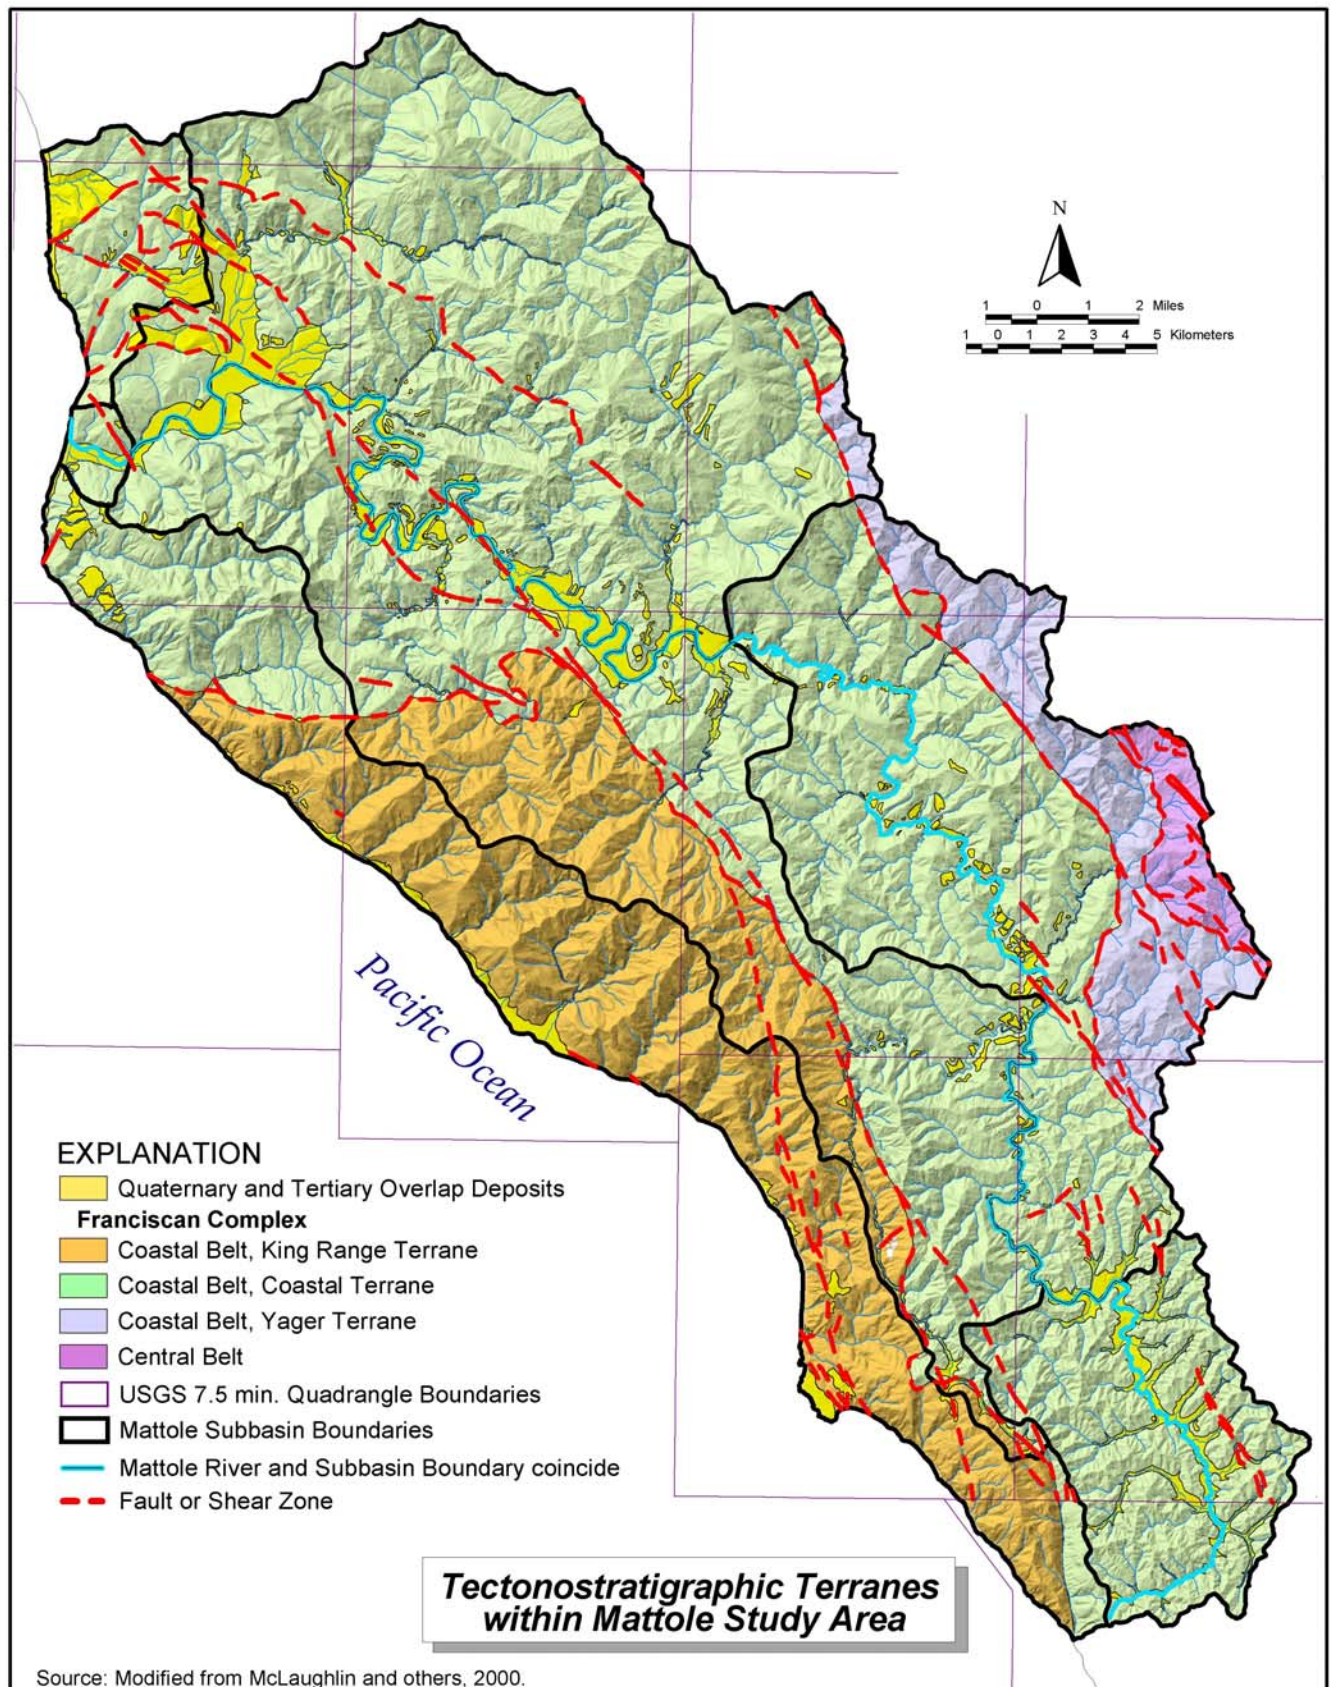
Figure 4. Tectonostratigraphic terranes within the Mattole study area.

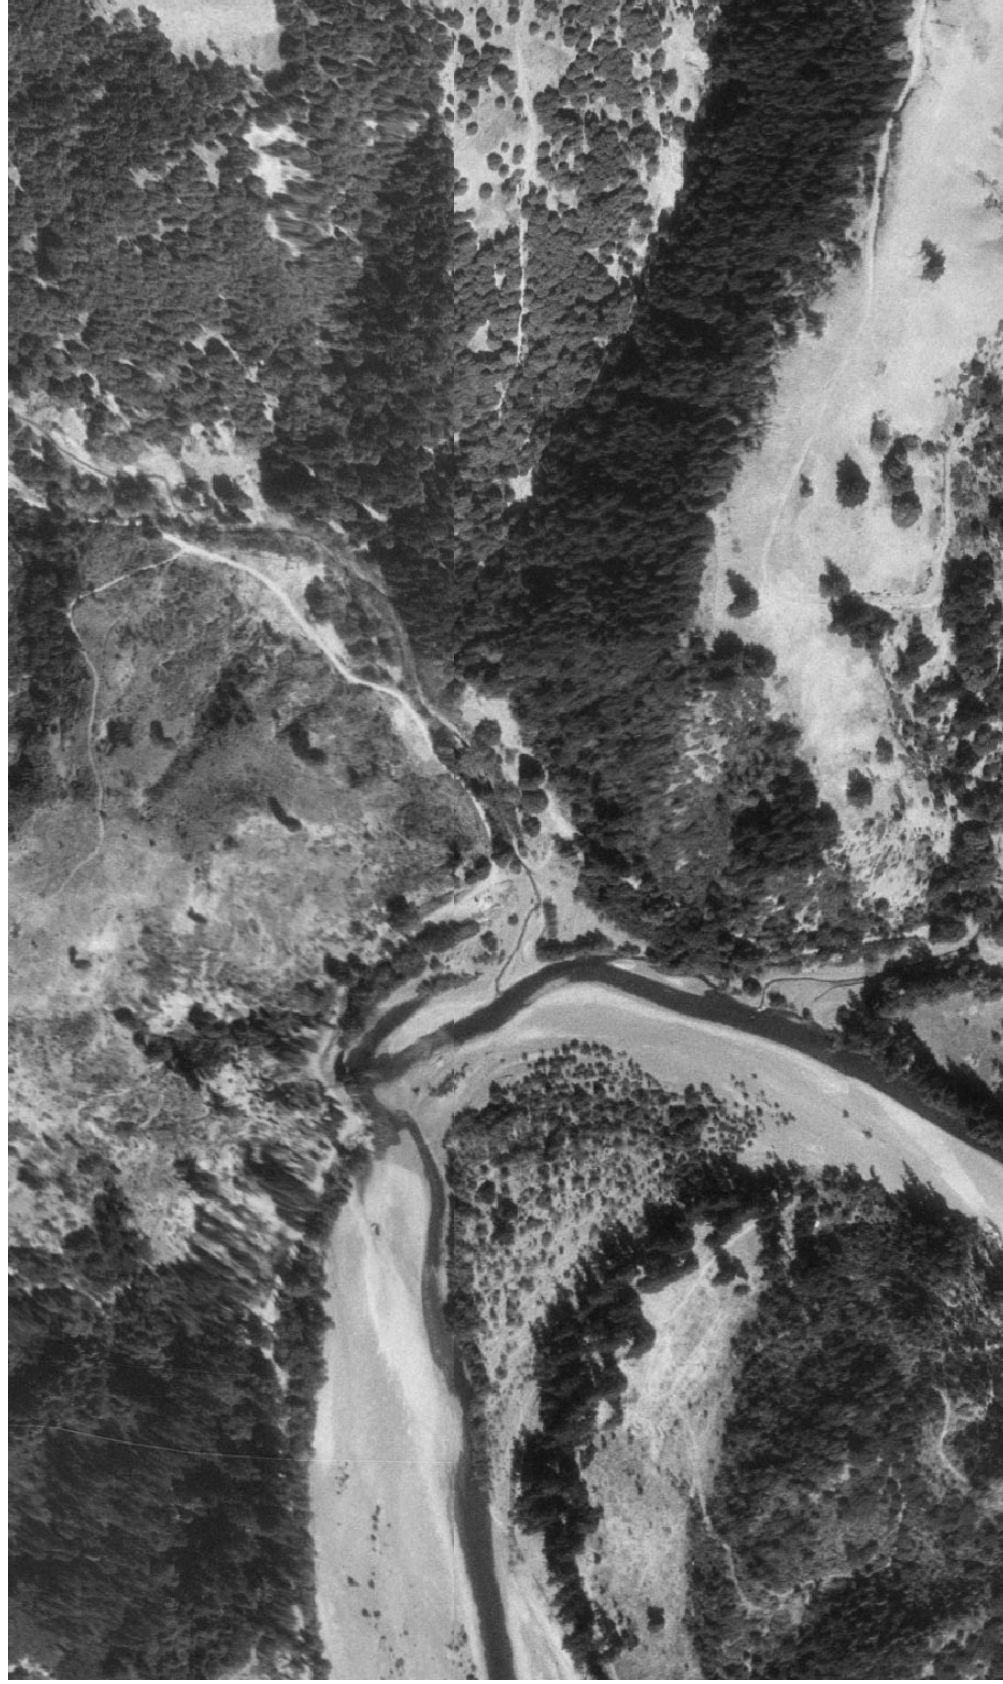
Figure 22. Tributary fan at Conklin Creek and mainstem Mattole River showing the effects of sediment deposition caused by a rapid transition from high gradient transport reach to low gradient response reach.

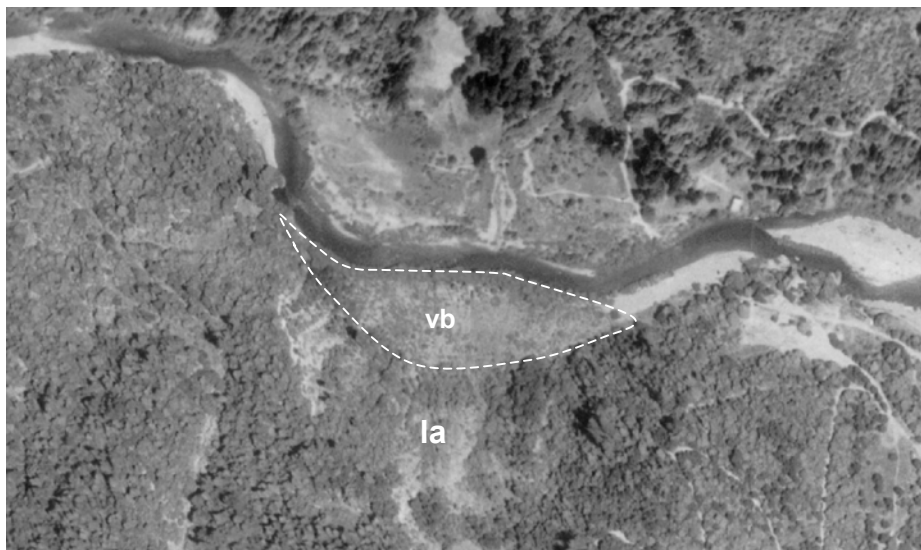
Vegetated lateral
bar at toe of
landslide
